# Exterior

## Roof

Inventory Condition and Assessment Program	
Exterior	
Elevation: Roof	
Room #:	
Room Name / Use: Roof Covering	
Date of Assessment: 5/22/99	
Photo No.:	
Feature Description	Condition
Shim behind D204 in R205 south jamb is believed to be a piece of older roofing called simply the "long shingle" also the "double bevel" "feather edge" and "biaxial shingle."	
The extant piece is 30" long, 2 3/4" wide, was wider but split to fit its current location. Beveled from 1/2" at low end to point at upper end. It appears to be beveled in the side to side direction but I could not tell for sure.	
Second piece in R 106 north floor joist, used as floor shim is 32" long, hand-shaved long shingle only beveled in length. Half width of 3" showing.

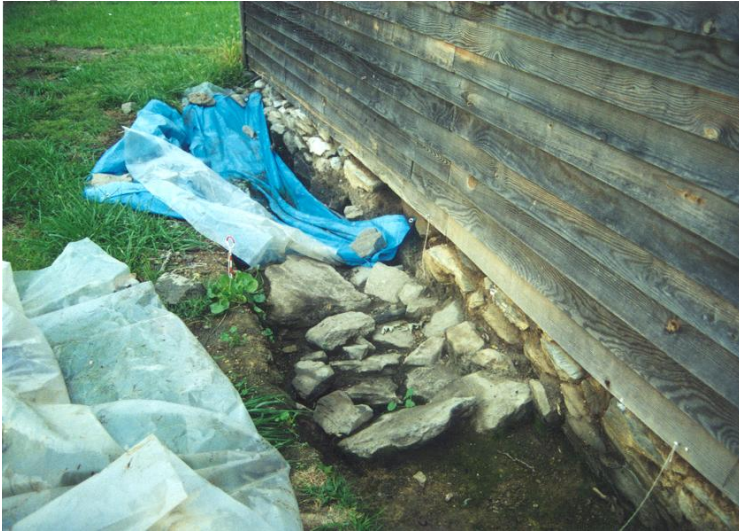
Excavation, along east wall of original house, showing porch stoop under W 105 (October 1999) - IACPH71.htm

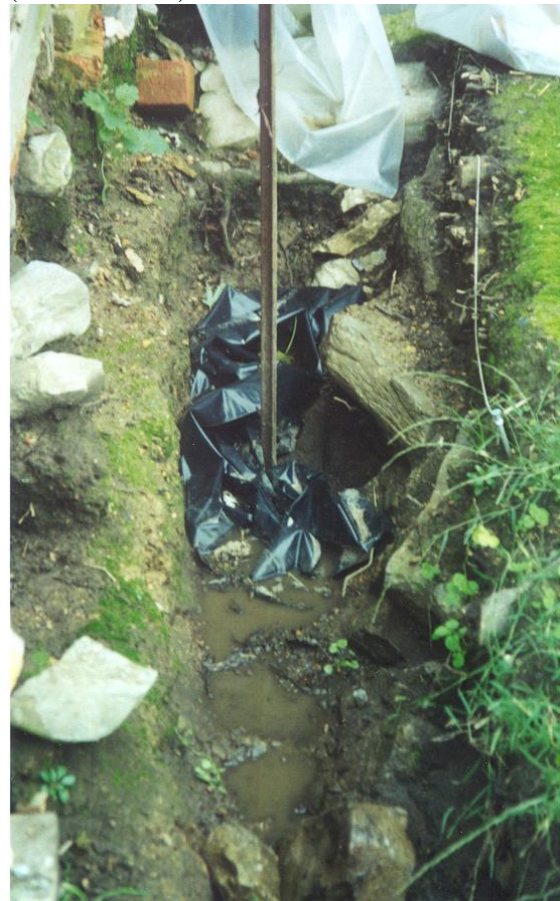
Excavation, along west wall of original house, showing stone foundation running parallel to original one (October 1999). - IACPH70.htm
