R205 – Loft

Inventory Condition and Assessment Program

Room #: R205

Peter Burr House

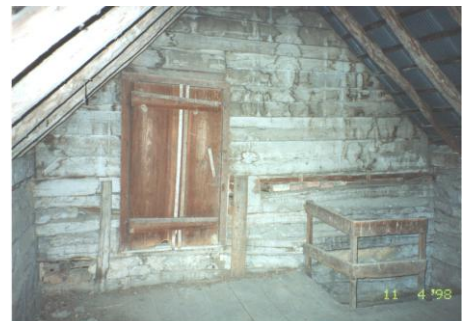
Loft, R205, east wall, D204, stair well.

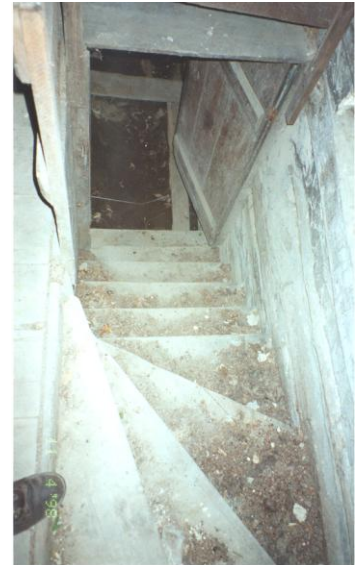
Stairs leading down to log kitchen

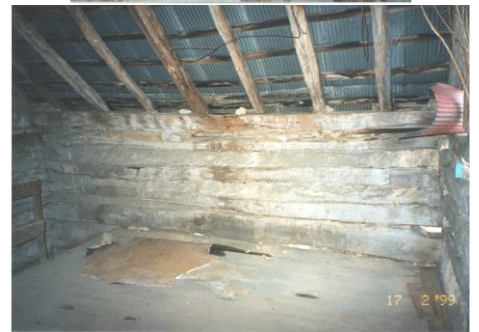
Loft, R205, south wall.

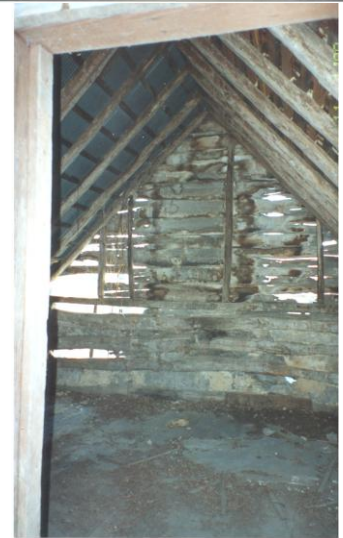
Loft, R205, west wall.

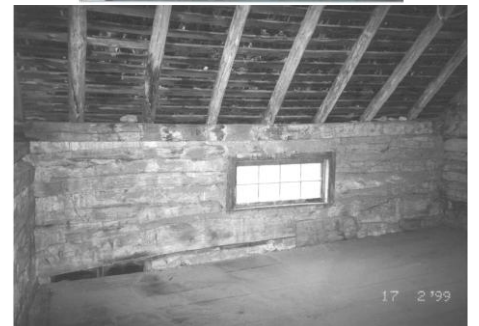
Loft, R205, north wall, W202.
